Cottage Hall Farm

National Register of Historic Places
Inventory—Nomination Form

historic Cottage Hall Farm; Albert Sudler Farm

and/or common George Maddox Farm (preferred)

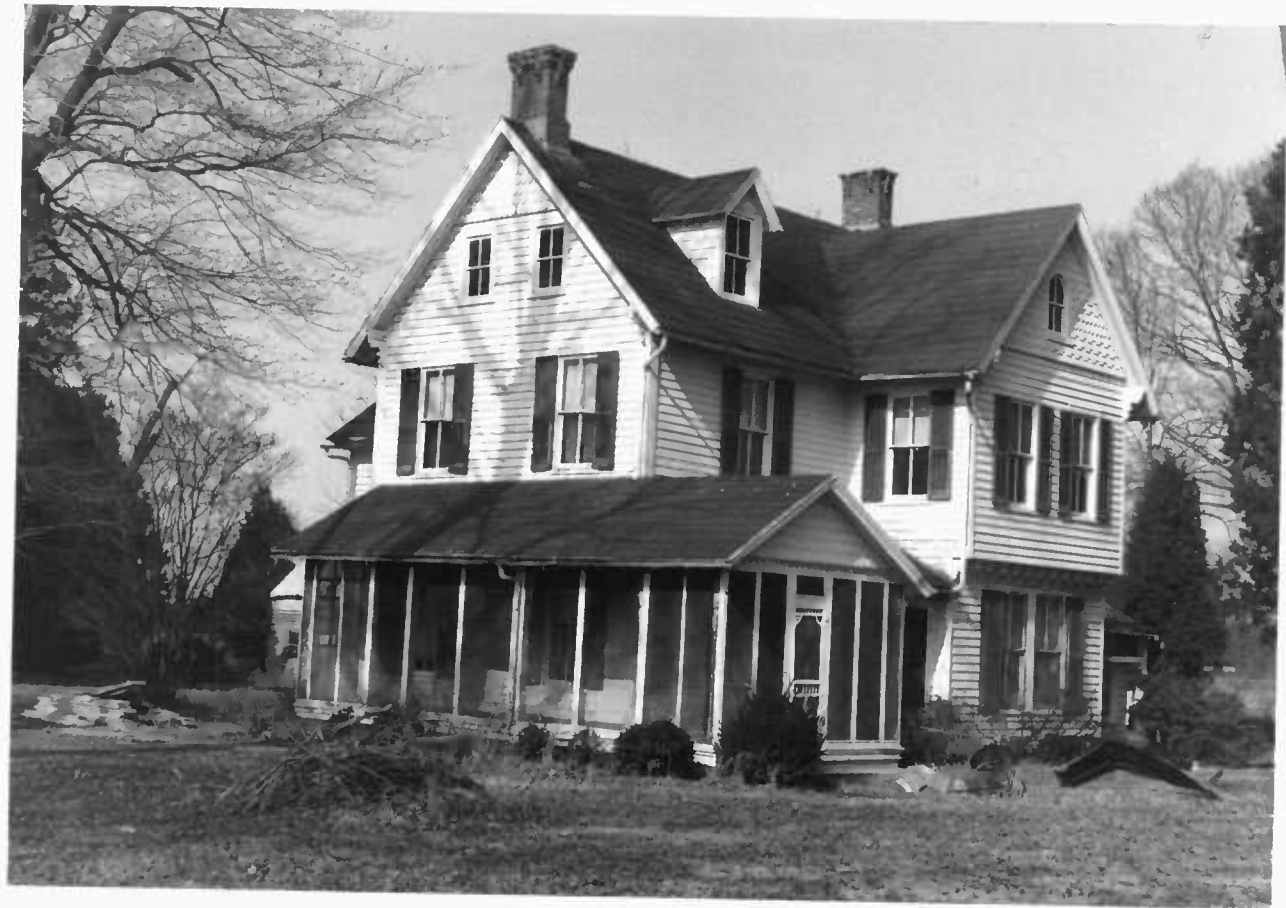
East (front) facade of Victorian house

The southern irregular elevation of the house serves as the entrance facade, while a turned post porch with sawn brackets partially covers the first floor. The gable end is two bays across with 2/2 sash windows and louvered shutters on both floors. Two 2/2 sash windows pierce the attic story and flank the interior end brick chimney. The chimney stack is finished with a decorative corbelled cap, and the uppermost portion of the gable end is sheathed with fishscale shingles. The eaves are extended, and a decorative bracket is found at each lower corner. The southeast corner of the cross-plan contains a double-leaf paneled door and an adjacent 2/2 sash window on the east wall. The second floor is lighted by two 2/2 sash windows, while the attic is lighted by a 2/2 sash dormer.

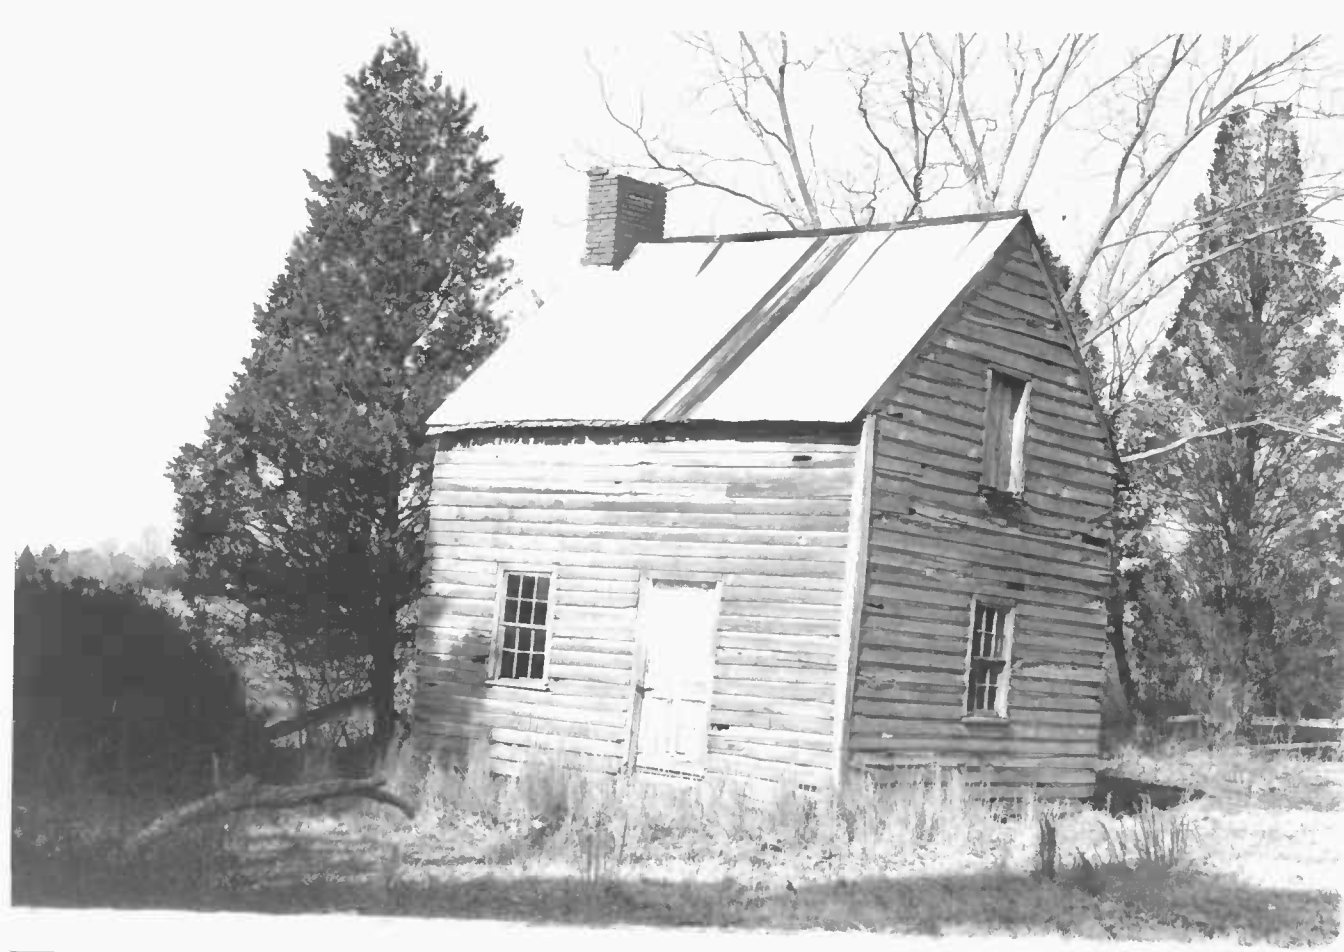
George Maddox Farm S-86
Manokin vicinity, Somerset Co., Md.
Kitchen - Southeast Elevation
2/84, Paul Touart, Photographer
Neg./Md. Historical Trust

The north end of the kitchen wing has an exterior seven-course common bond brick stack with corbelled shoulders. The wall is pierced by a boarded door opening west of the stack and two four-pane attic windows that light the loft. The bargeboard is beaded.

The west side of the kitchen has two six over six sash windows with louvered shutters on the first floor, and a shed roofed dormer with exposed rafter feet lights the loft. The cornice to the kitchen is boxed and the fascia board has a corner bead.

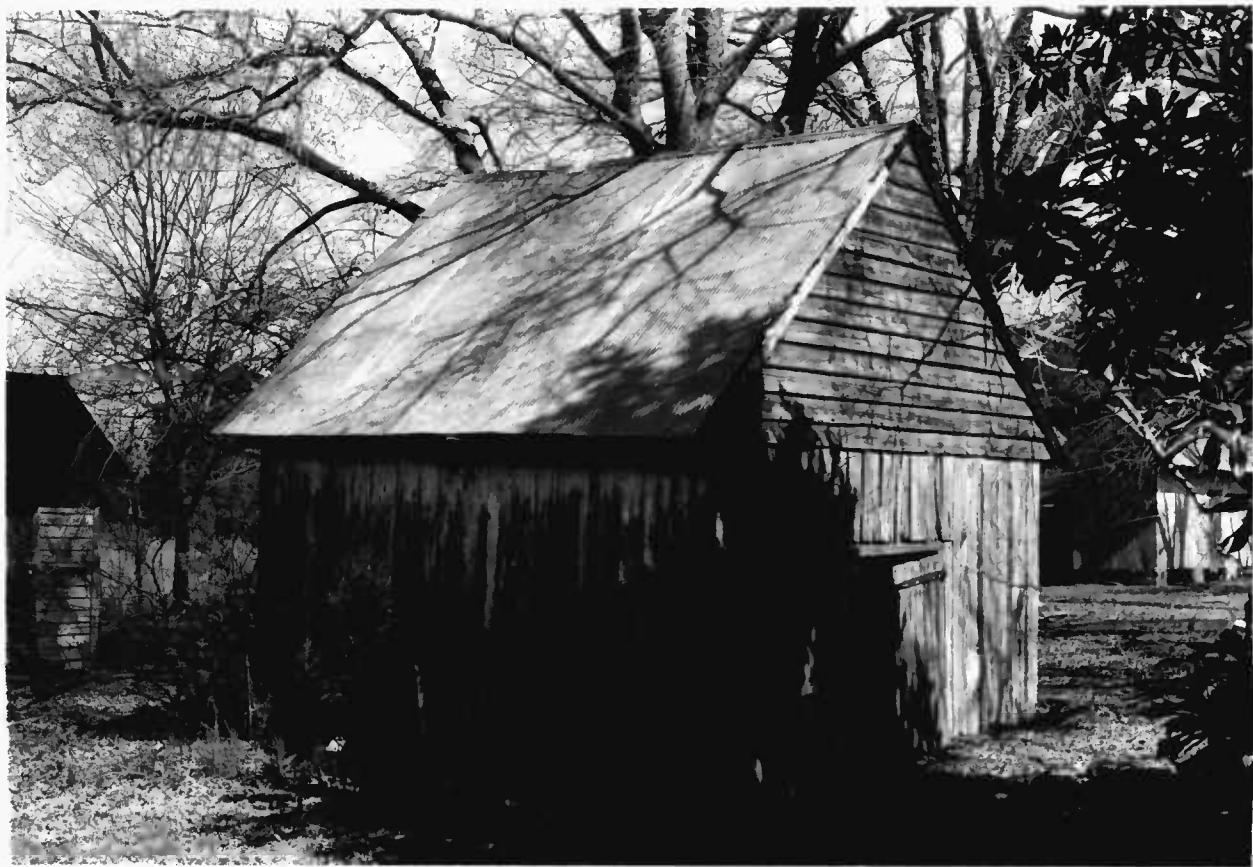
George Maddox Farm
Southwest Elevation of Smoke House
Near Manokin, Somerset County
3/84 Paul Touart
Neg./ Maryland Historic Trust

The c. 1830-1850 single-story gable front smokehouse stands northwest of the frame dairy and shares a southern exposure with the dairy buildings. The full dovetailed log structure is sheathed with vertical board siding with rabbetted joints fastened with cut-nails. A steeply pitched corrugated tin roof covers the structure. The joist ends are enclosed within the boxed eave.

The south side has a centered board and batten door with one surviving spade-tip strap hinge. The gable end framing is covered with beaded horizontal weatherboards.

The interior is fully blackened and filled with nails and hooks for hanging meat. Two layers of collar beams with lapped joints rise above the joists. The gable ends are framed with a grid pattern of small three-foot studs. The rafter pairs have a mortise and tenon joint and are fastened with mature cut-nails. The floor has been removed for the most part, but a section of joists and flooring remains against the east wall.

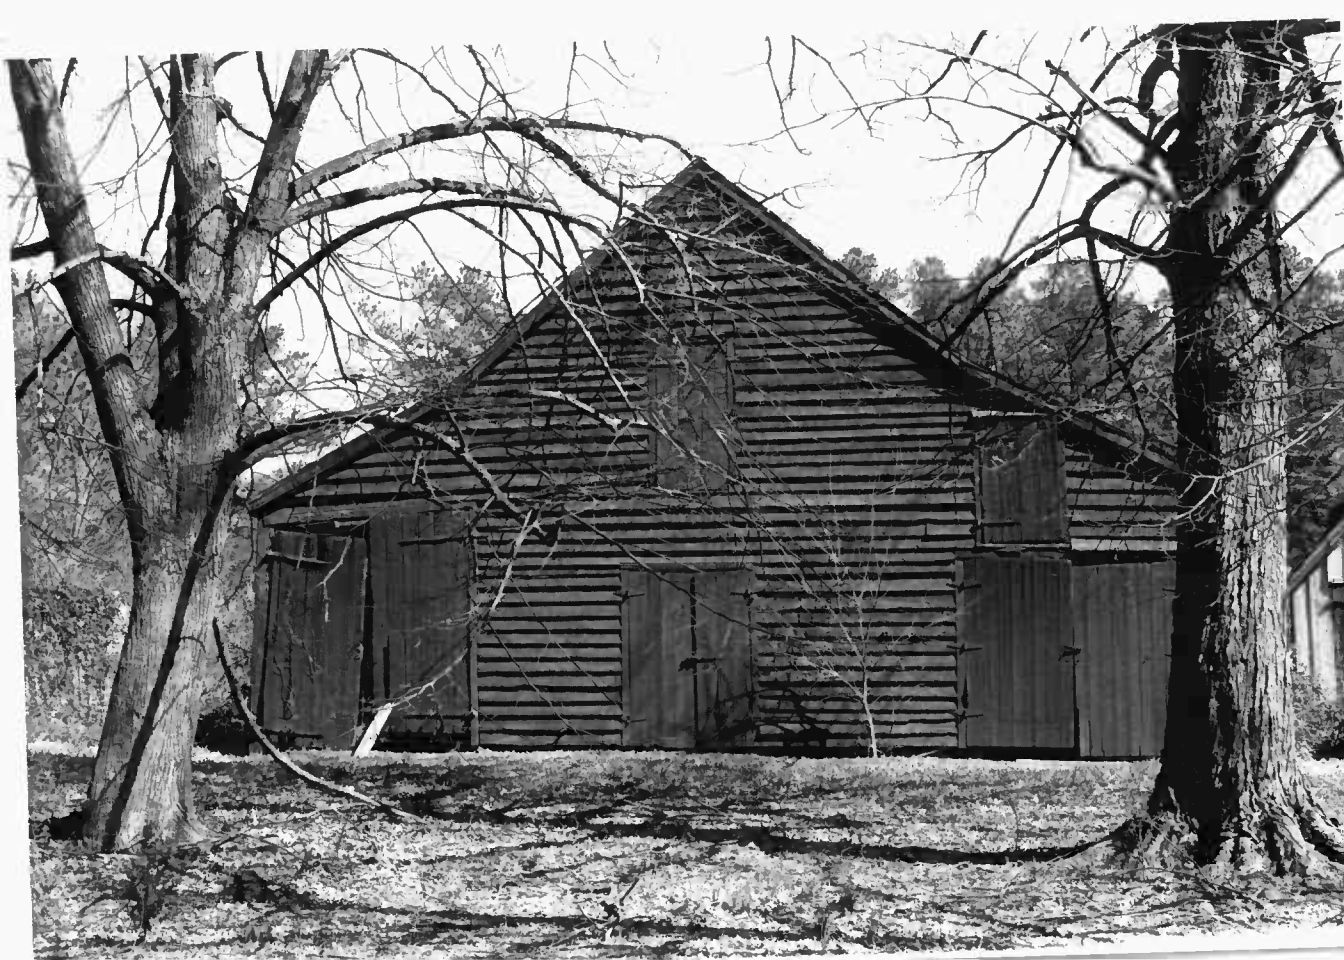
George Maddox Farm S-86
Manokin vicinity, Somerset Co., MD.
Granary - West elevation
3/84, Paul Touart, Photographer
Neg./MD. Hist. Trust

The granary stands on the east side of the farmyard and faces west. Standing on a brick pier foundation the mortise and tenon frame is largely sheathed with beaded weatherboards and covered by a steeply pitched asphalt shingle roof. The roof pitch breaks into a gentler slope as it extends over each side shed.

The granary dates from two periods. The center, squarish core is a wrought-nail, pit-sawn, mortise and tenon frame structure which apparently stood by itself before the circular-sawn, cut-nail, side sheds were attached. Sheared off nails on each inner side wall, along with unused door openings in each inner wall, suggest that the sheds were added later. The original use of the center section has not been determined.

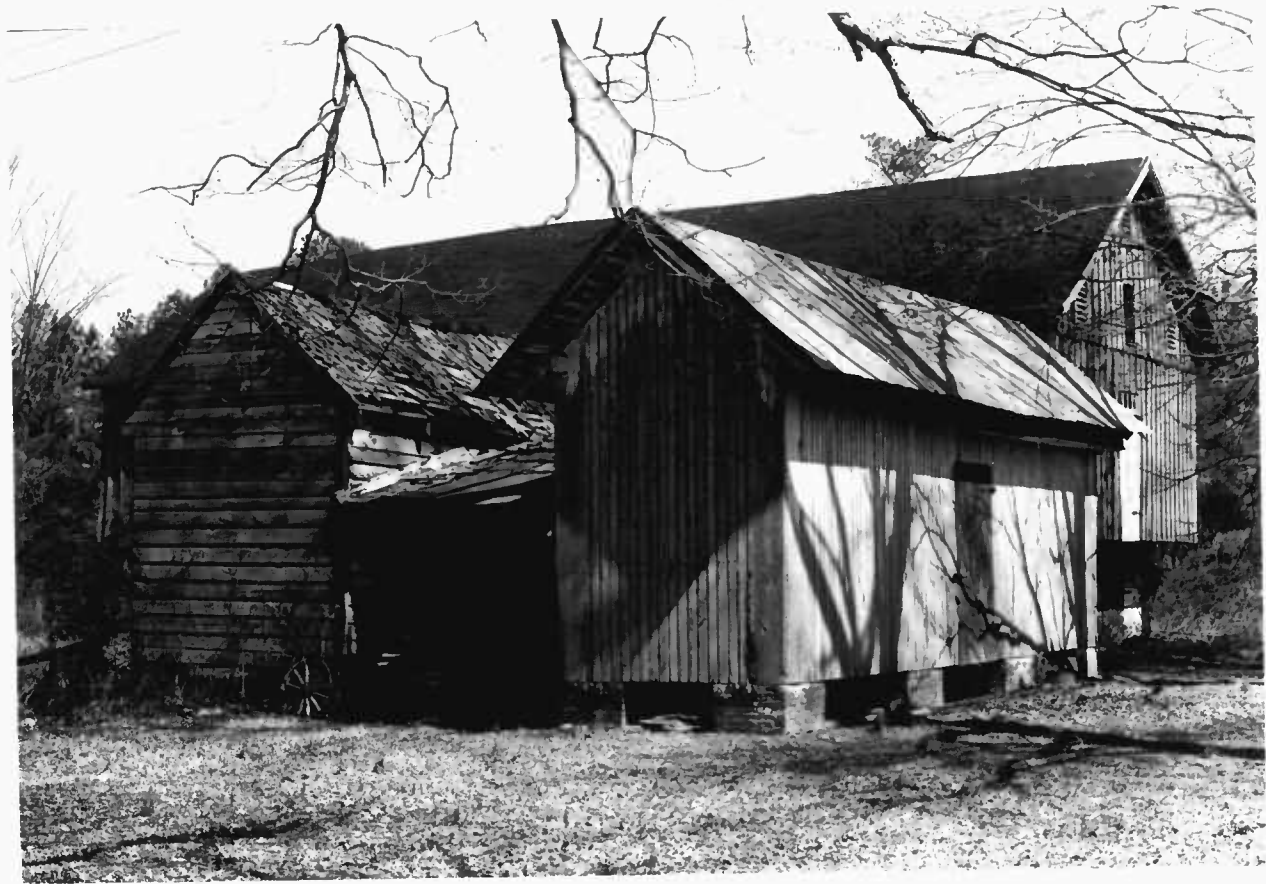
George Maddox Farm
Near Manokin, Somerset County
Southwest Elevation of Corn Cribs
3/84 Paul Touart
Neg./ Maryland Historic Trust

A pair of corn cribs stand in the central portion of the farmyard immediately west of the board and batten barn. The two cribs date from different periods. The northernmost crib is a c. 1810-30 rectangular frame crib with beveled horizontal board siding, while the second crib is a c. 1850-1870 frame structure with vertical slat siding. Both structures rest on brick pier foundations and are connected with a gabled roof passage used for implement storage.

The north crib is a mortise and tenon frame structure with a single board and batten door in each long side. Both the battens and boards are finished with corner beads, while the doors hang on spade-tipped strap hinges. The medium sloped wood shingle roof has exposed joist ends. The common rafter roof system rests on a board false plate, and the rafter pairs have a mortis and tenon peak joint. The structural framing is pit sawn.

The southern crib is a circular sawn mortise and tenon frame structure with the same basic plan. Two small window openings are located on the inner wall surface. In contrast to the earlier crib, the eaves and rafter feet are extended, and a dove cote is located under the southeastern portion of the roof. In addition, the framing system has up braces instead of down, and a ridge board runs between the rafter pairs.

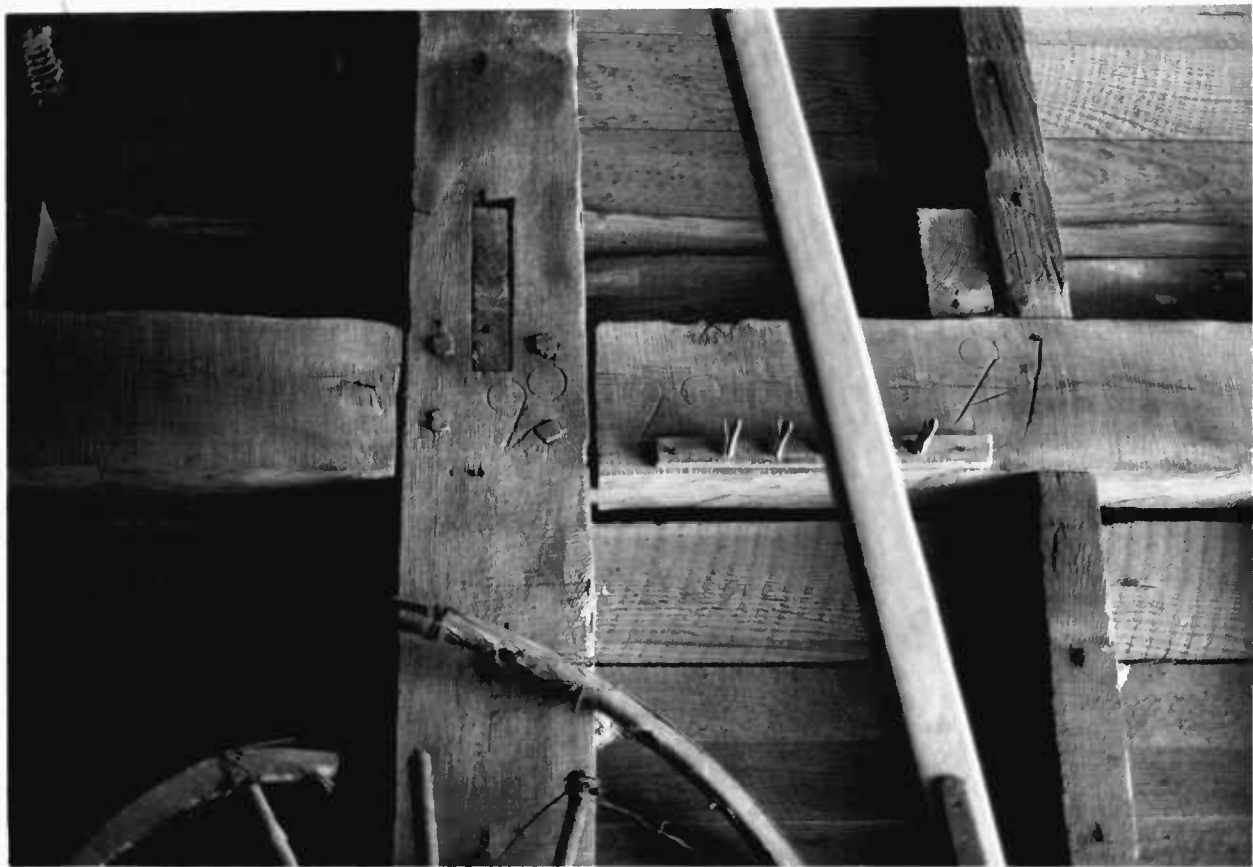
George Maddox Farm
Framing Detail of Granary
Near Manokin, Somerset County
3/84 Paul Touart
Neg./ Maryland Historic Trust

The second floor is divided into bins for grain storage. One tier of collar beams are half-dovetailed and fastened with wrought nails. The gable ends are framed with two tiers of studs, and the rafter pairs have pinned mortise and tenon joints.

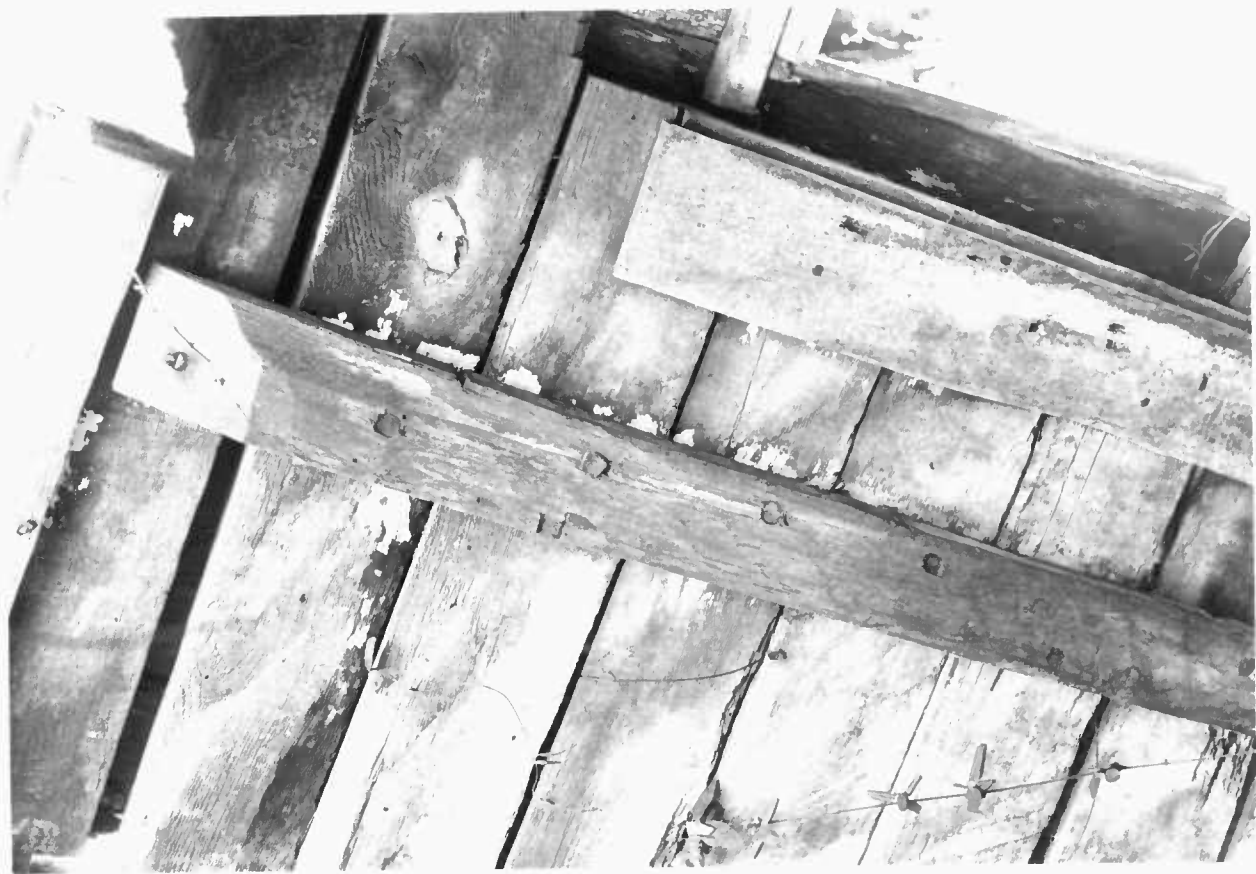
George Maddox Farm
Detail of Log Support
Near Manokin, Somerset County
3/84 Paul L. Touart
Neg/ Maryland Historic Trust

The remnants of a wrought-nail log outbuilding with an exposed eave stand immediately southeast of the barn. The outbuilding's original use has not been determined, but structural evidence suggests a slave quarter or a stable. One unusual feature is the vertical hewn wall supports that are fastened with wrought spikes and wooden pegs. The eaves are exposed and have pins dropping through the false-plate and the joist ends. The logs are pit sawn and joined at the corners with a full dovetail notch. Some of the vertical siding have a beveled edge and are fastened with wrought-iron nails.

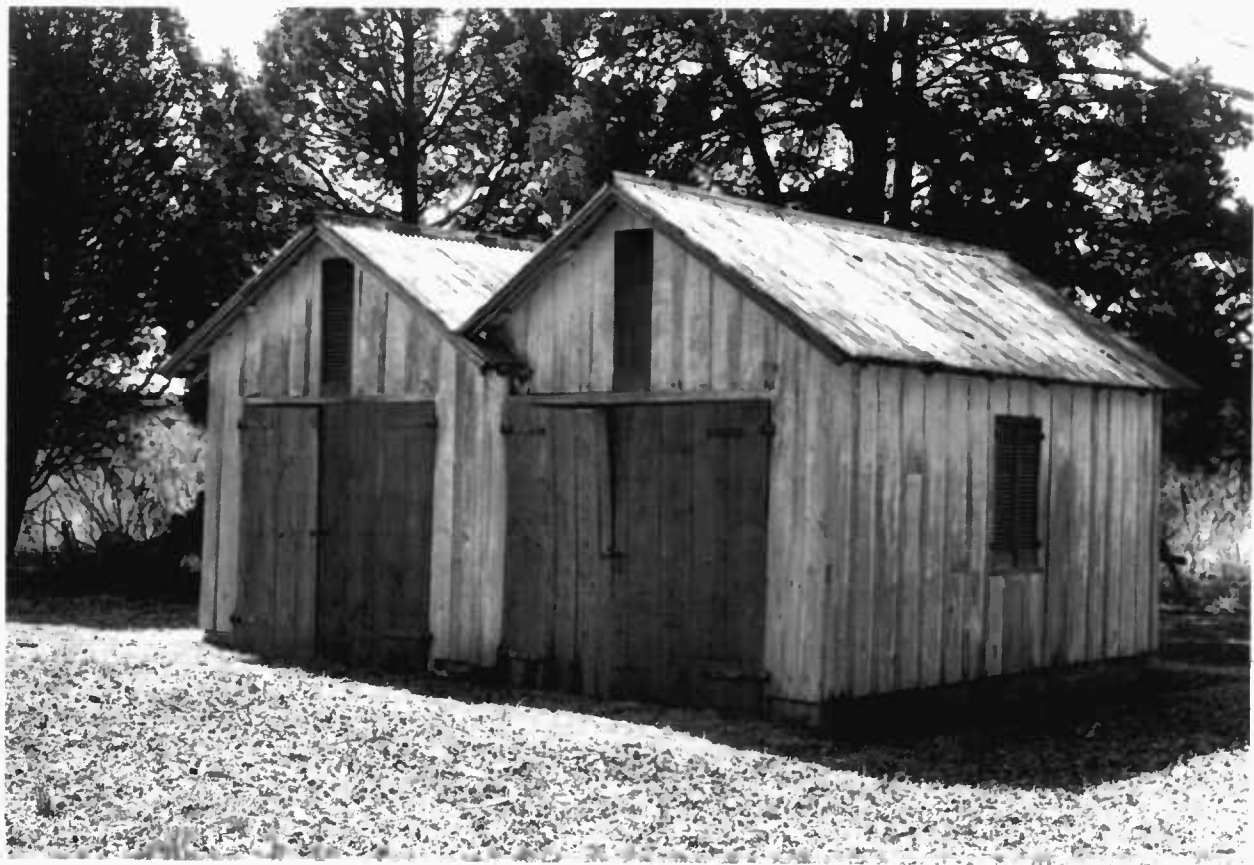
George Maddox Farm
Near Manokin, Somerset County
Northeast Elevation of Garage
3/84 Paul Touart
Neg./ Maryland Historic Trust

Standing immediately south of the granary is a c. 1890 one-car board and batten frame garage. The rectangular structure straddles the ditch on the eastern edge of the farmyard and rests on brick piers. The steeply pitched roof is covered with corrugated tin over wood shingles. The west gable front has a double door garage opening that swings on an assortment of strap hinges. A small screened vent is located in each gable end.
